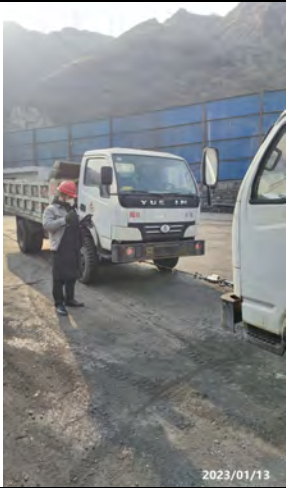
238	GX-B1417/22-2-23004	2023. 1. 17	综合判定：合格

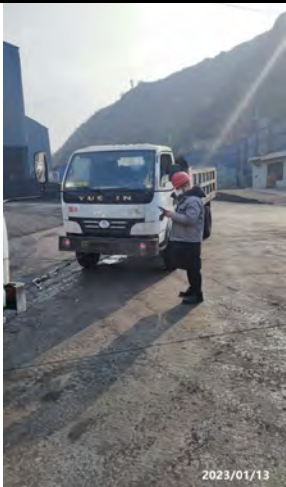
239	GX-B1417/22-2-23005	2023. 1. 17	综合判定：合格

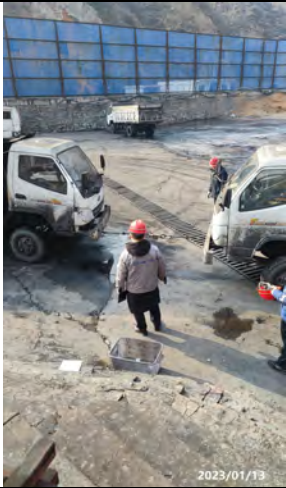
242	GX-B1417/22-2-23008	2023. 1. 17	综合判定：合格

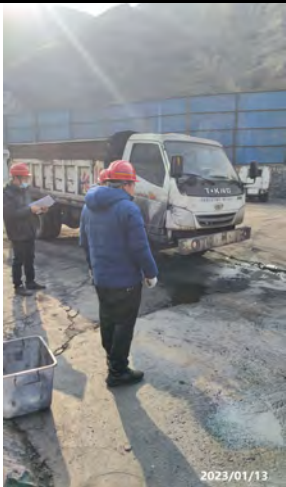
243	GX-B1417/22-2-23009	2023. 1. 17	综合判定：合格
