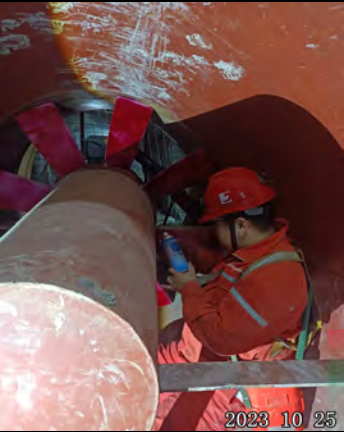
9	GX-B1428/21-6-23031	2023/11/2	无缺陷迹痕显示

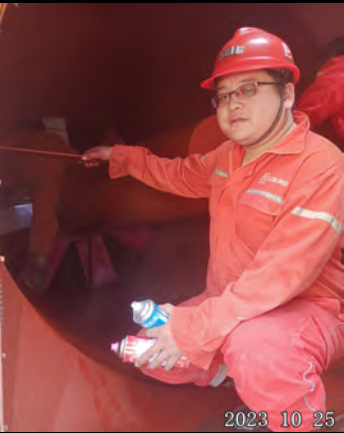
10	GX-B1428/21-6-23032	2023/11/2	无缺陷迹痕显示

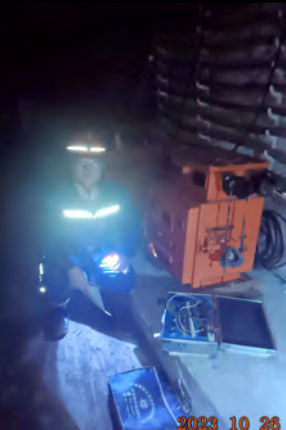
11	GX-B1352/21-6-23461~23464	2023/11/2	所检项目合格

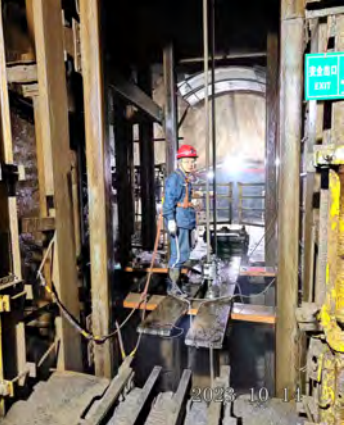
15	GX-B1598/21-6-23051	2023/11/3	<p>实测钢丝绳有效截面积损失百分比最大为1.43%，小于5%为正常。</p>	 
16	GX-B1598/21-6-23052	2023/11/3	<p>实测钢丝绳有效截面积损失百分比最大为1.20%，小于5%为正常。</p>	 
17	GX-B1598/21-6-23053	2023/11/3	<p>实测钢丝绳有效截面积损失百分比最大为4.84%，小于5%为正常。</p>

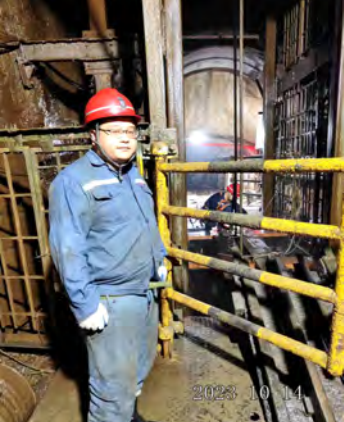
18	GX-B1598/21-6-23054	2023/11/3	实测钢丝绳有效截面积损失百分比最大为4.85%，小于5%为正常。
