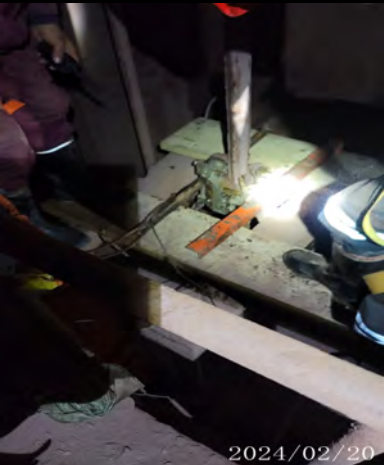
101	GX-B1598/21-2-24015	2024. 2. 27	实测钢丝绳有效截面积损失百分比最大为1.53%，小于5%为正常。

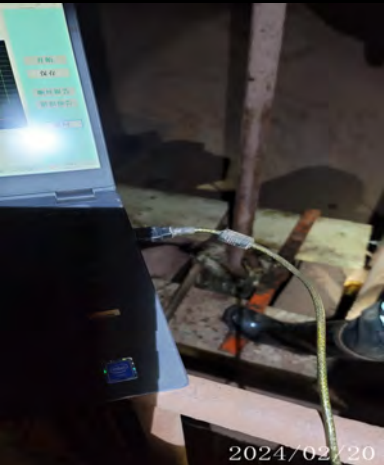
103	GX-B1598/21-2-24017	2024. 2. 27	实测钢丝绳有效截面积损失百分比最大为1.77%，小于5%为正常。

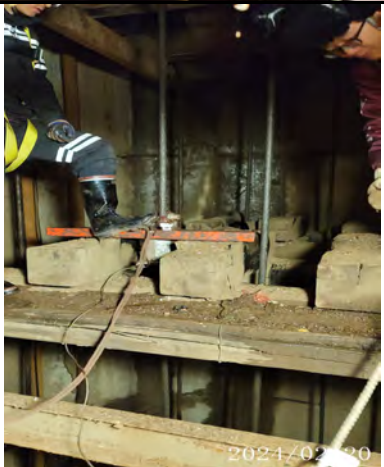
104	GX-B1598/21-2-24018	2024. 2. 27	实测钢丝绳有效截面积损失百分比最大为0.63%，小于5%为正常。
