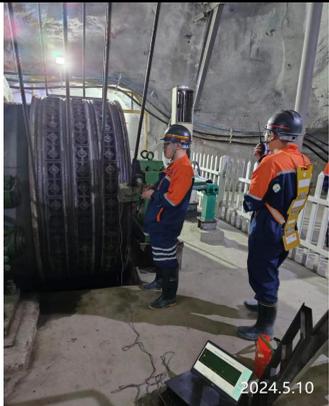
序号	报告编号	发布日期	结论	影像资料
48	GX-B1598/21-3-24001	2024. 5. 23	实测钢丝绳有效截面积 损失百分比最大为 1.42%，小于5%为正常 。

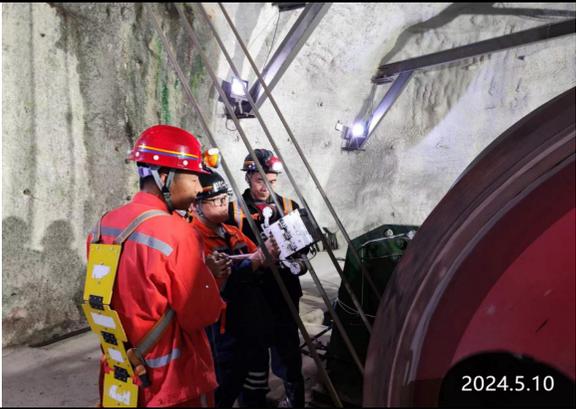
A photograph showing two workers in orange safety gear and hard hats inspecting a large, dark-colored steel cable spool. The workers are standing on a concrete floor in an industrial environment. A date stamp '2024.5.10' is visible in the bottom right corner of the image.
49	GX-B1598/21-3-24002	2024. 5. 23	实测钢丝绳有效截面积 损失百分比最大为 1.80%，小于5%为正常 。

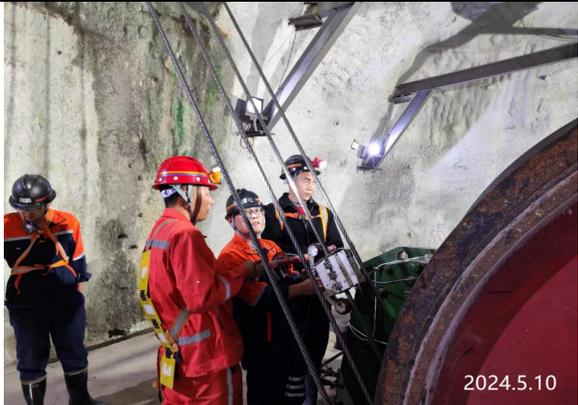
50	GX-B1598/21-3-24003	2024. 5. 23	实测钢丝绳有效截面积 损失百分比最大为 1. 49%，小于5%为正常 。

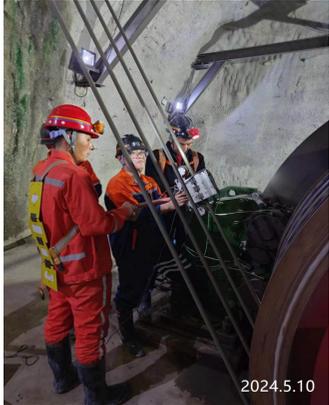
<p>2024.5.10</p>
51	GX-B1598/21-3-24004	2024. 5. 23	实测钢丝绳有效截面积 损失百分比最大为 0. 89%，小于5%为正常 。

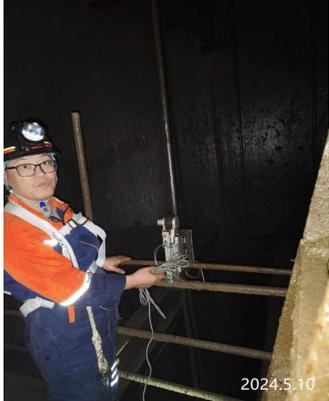
<p>2024.5.10</p>
52	GX-B1598/21-3-24005	2024. 5. 23	实测钢丝绳有效截面积 损失百分比最大为 0. 89%，小于5%为正常 。

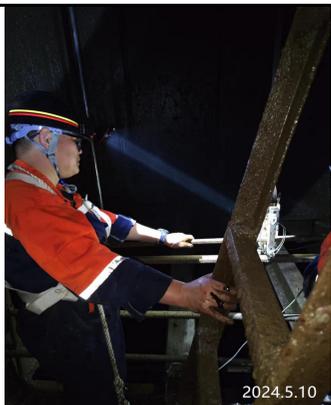
53	GX-B1598/21-3-24006	2024. 5. 23	实测钢丝绳有效截面积 损失百分比最大为 0.76%，小于5%为正常 。
